Vermont Circuits Inc.
Brattleboro, VT

Reroofing an existing Corrugated Metal Roof

20,000 SF Corrugated Metal Roof System

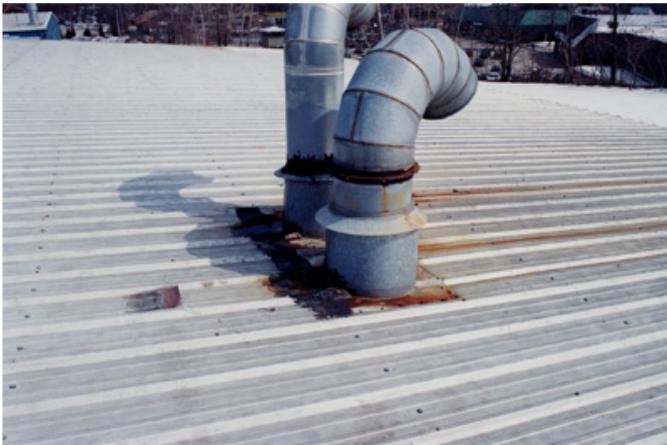
The metal roof on the building, constructed in the mid 1980's, was showing signs of rapid deterioration, manifested by major leaks at panel laps and fastener penetration points. During the winter months, ice build-up at the eaves resulted in damming up of water that would find its way into the interior of the building.

Stack Penetrations through old metal roof system

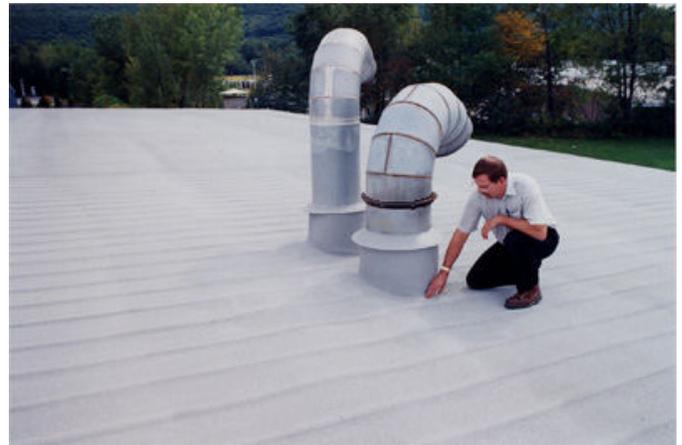
Stack Penetrations with new Seamless Spray-Foam roof system

- A new metal fascia/foam stop was first installed.
- Loose or missing fasteners were tightened or replaced.
- A primer was applied to the existing metal roof panels.
- An average two inches of seamless polyurethane foam insulation then was spray-applied.
- Two layers of silicone elastomeric protective coating were then spray-applied over the new insulation.
- Ceramic granules were broadcast into the top coating layer for additional durability.
