Hannaford Brothers Co. Distribution Center
Schodack Landing, NY

Existing Roof

160,000 SF Ballasted EPDM Freezer & Cooler Areas

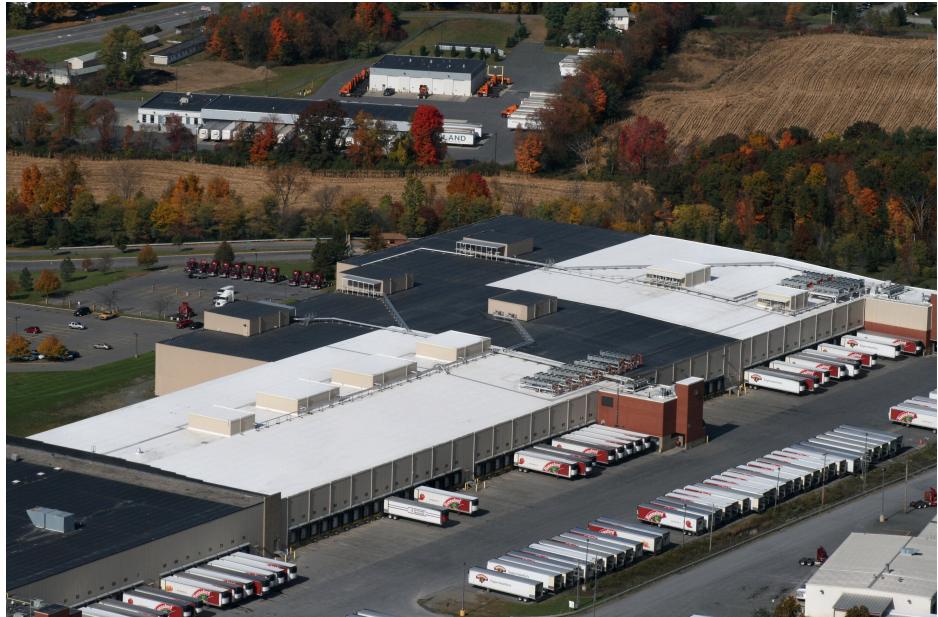
BEFORE & AFTER

Increased leaks were developing in the 16 and 18-year-old EPDM sections of Hannaford's freezer and cooler warehouse roofs.

With the roof's insulation thickness approaching eight inches, Hannaford chose to be proactive and reroof while they could still salvage their existing insulation. Total removals of all roofing and insulation would have proven extremely costly, with serious disruption, particularly over their freezer area.

Mechanically attached TPO Heat-Welded Single-Ply Roof System.

After removing 800 tons of stone ballast and more than 5,000 concrete pavers, installation of the new roof system proceeded smoothly and safely. One inch of additional polyisocyanurate insulation was installed, providing an acceptable substrate for the new membrane, and an R-6 increased insulation value. A 60 mil, white, reinforced TPO membrane was then mechanically attached to the underlying steel deck in compliance with the manufacturer's specifications. All membrane seams were hot air welded, providing the industry's strongest seams and maximum protection. Walkway areas previously comprised of concrete pavers were then replaced with new TPO walkway tread, heat-welded to the new membrane.

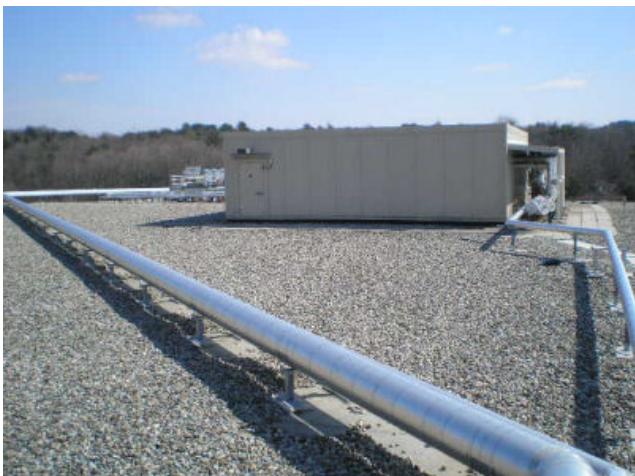
Old Ballasted EPDM Roof

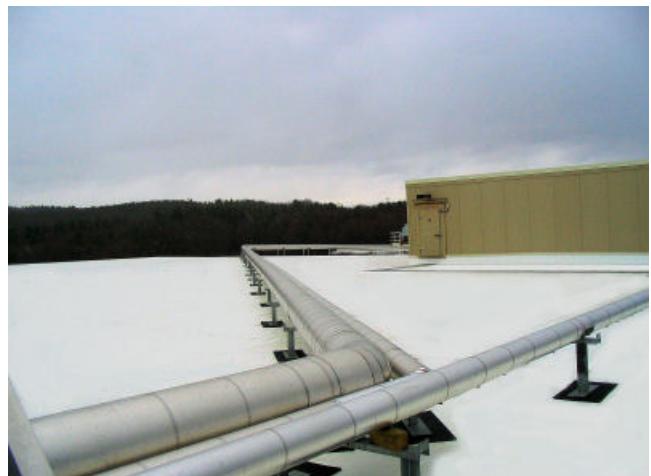
New Heat-Welded TPO Roof Membrane
