## Client

**Manufacturing/Warehouse Complex**  
Upstate, NY

## Reroofing an existing Mechanically Attached Single Ply Roof

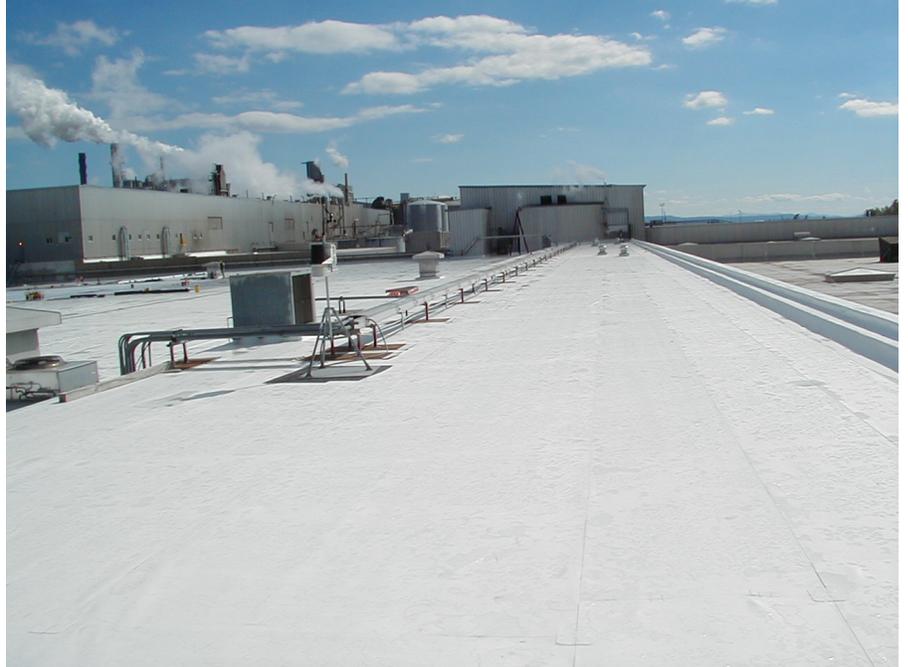
The existing 45-mil hypalon single-ply membrane, originally installed by Carruthers, was showing signs of deterioration and mechanical damage after 19 years of service. With an asbestos-containing built-up roof underneath, the owner decided to replace the hypalon membrane before more extensive removals were needed.

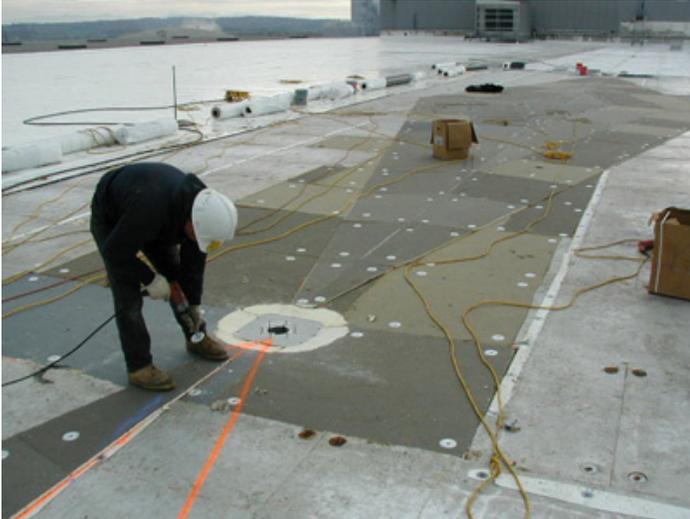
Installation of Tapered Insulation Crickets  
Between Drains

The old membrane was first removed, exposing the underlying insulation. Areas of wet insulation were removed and replaced. New drain inserts were installed, along with tapered insulation crickets between drains for improved drainage. Rolls of 60-mil, white, reinforced TPO membrane were then mechanically fastened to the underlying steel deck, and all seams hot-air welded. All curbs, pipes and expansion joints were covered with new TPO membrane flashing. Also, being in a high wind area, the owner opted for a new metal edge/fascia system, supplied and warranted by the roof system manufacturer.

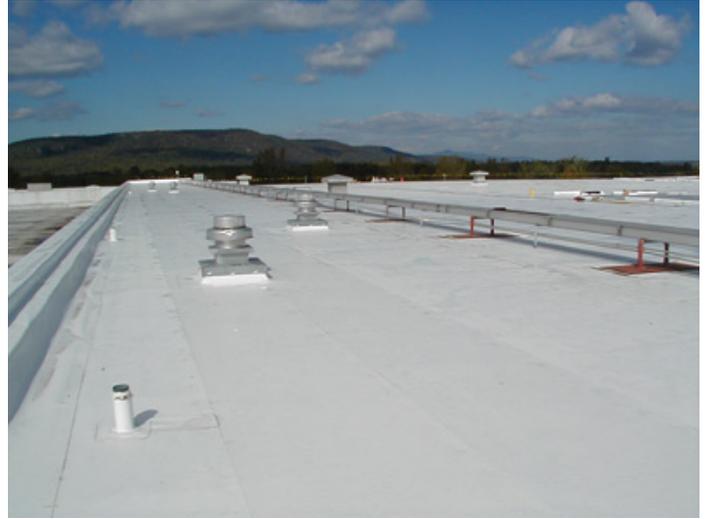
New Heat-Welded TPO Reinforced  
Roof Membrane
