National Grid
Albany, NY

Reconditioning an existing Spray Foam Roof System

42,000 SF Spray-Applied Polyurethane Foam (SPF) Roofing System

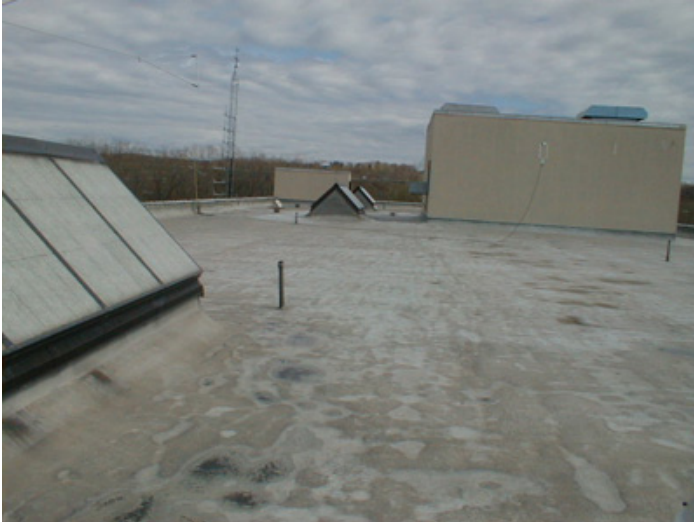
Old 1984 Spray-Foam roof system

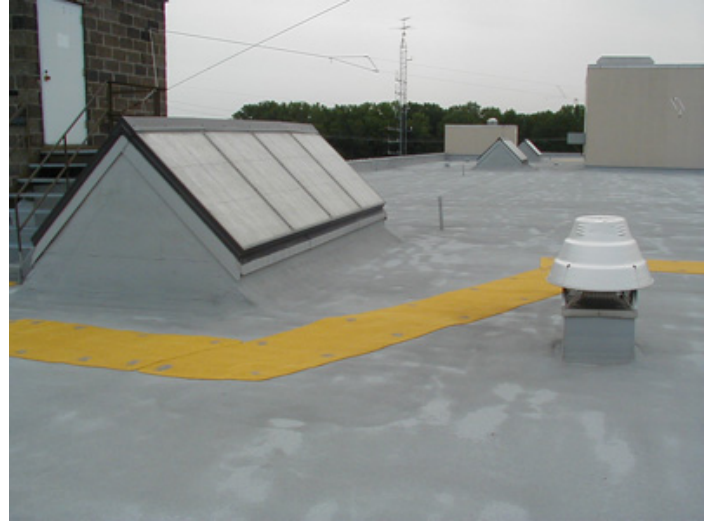
Spray-Foam roof with new Silicone Coating and Granules

- Areas of wet insulation were first removed and replaced with new foam insulation.
- The new foam insulation was then scarified to match the level of adjacent surfaces.
- The entire roof was power washed, removing all loose granules, dust, dirt and debris.
- All joints in the building's ceramic tile coping were checked and caulked as required.
- Two layers of new silicone membrane coating were spray-applied to the specified thickness.
- New ceramic granules were broadcast into the topcoat, providing enhanced durability and a non-skid surface.
- New protective walkway pads were installed where indicated in the project's specifications.
- Upon completion, a new 10-Year full-system labor and materials warranty was provided.
