A. Schonbek & Company, Inc.
Plattsburgh, NY

Reroofing An Existing Standing Seam Metal Roof

33,000 SF Standing Seam Metal Roof System

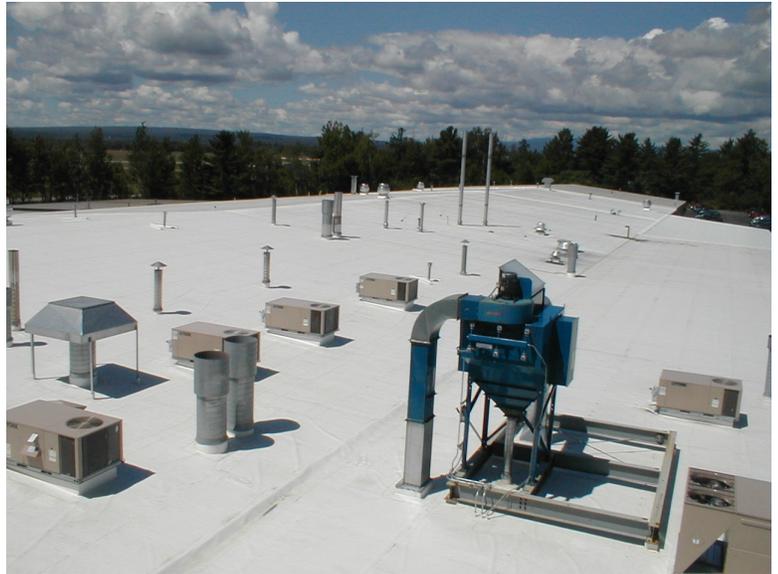
After too many harsh upstate New York winters, their standing seam metal roof was experiencing increased leaks, particularly around their many stack and curb penetrations, and at a tie-in to an adjacent roof. Excessive heat loss was also a concern, due to the ineffectiveness of the fiberglass insulation on the underside of their roof deck.

After an in-depth analysis, including a careful inspection of all flashing details and pull-tests to determine the holding power of fasteners into the metal panels, S. D. Carruthers recommended a mechanically attached, reinforced TPO single-ply roof system.

Expanded polystyrene insulation was first loose-laid between the metal panel ribs, and overlaid with an additional layer of polyisocyanurate, fastened to the underlying metal panels. Rolls of white, scrim-reinforced, TPO membrane were then mechanically fastened, and seamed together with an automatic hot-air welding machine.

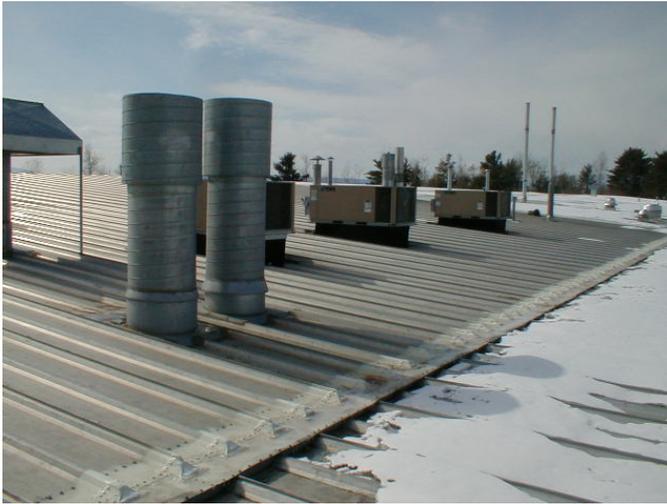
Old standing-seam metal roof

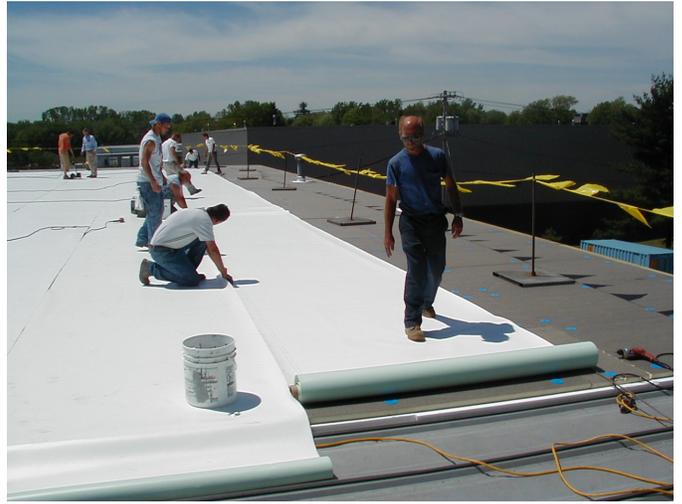
Crew positioning TPO membrane over new insulation
